Mersey White Water Regional Reserve – Bushfire Damage Update

John Borojević
Chair – Canoe Tasmania Inc.

8 March 2016

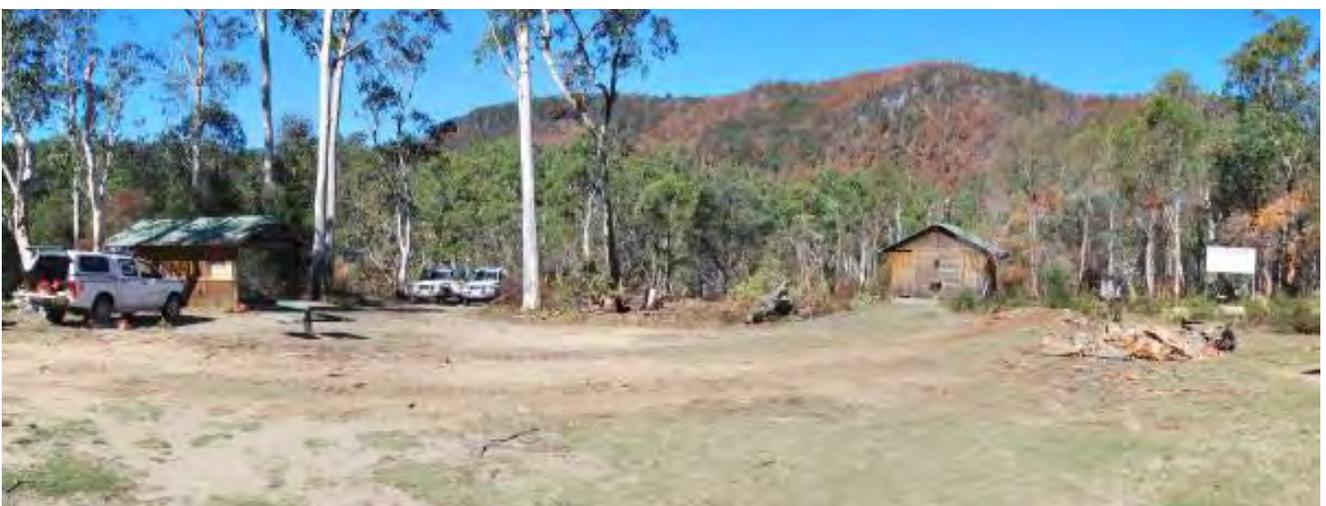
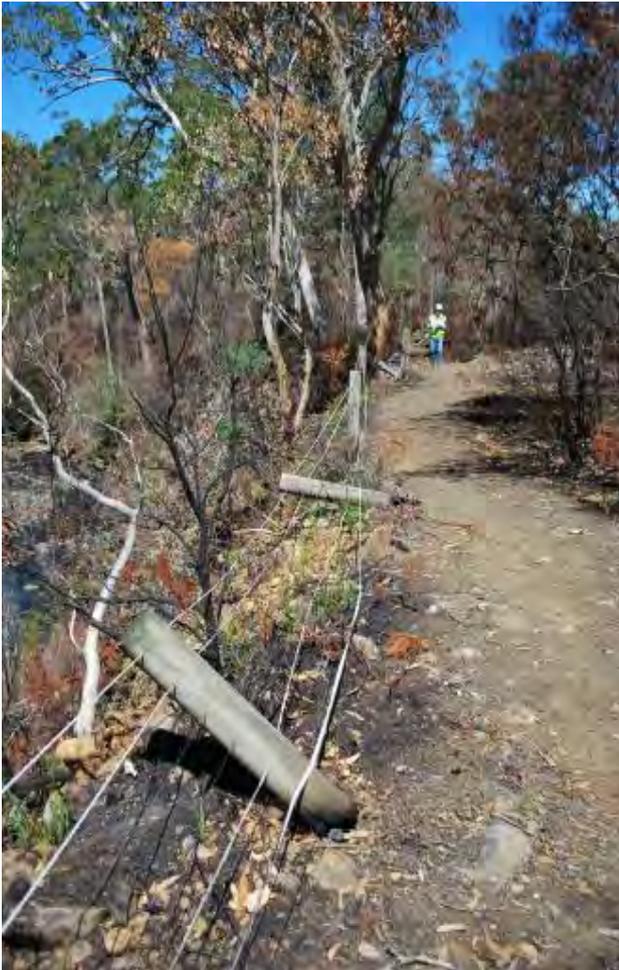
At the slalom course the picnic shelter, picnic tables and toilet block have not been damaged but the area around the toilet block has been burnt. A number of trees in this area burnt in the base and had to be felled.

The fence at the look out over the cliff between the picnic shelter and the toilet block has been burnt in sections with around 1/3 of the posts burnt out at the bottom. Some of the trees over the bank in this section had to be fallen as they were unsafe as were a number in the picnic ground.

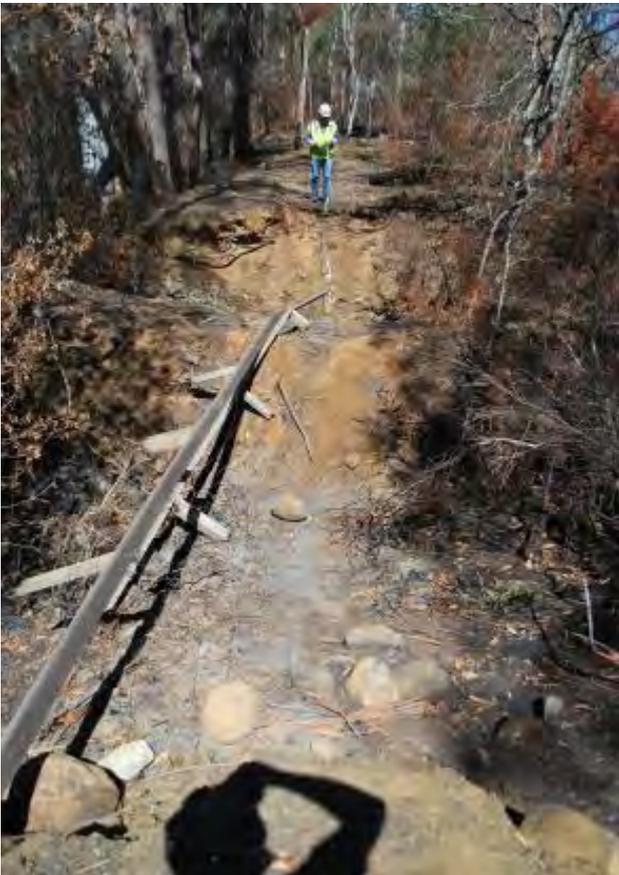
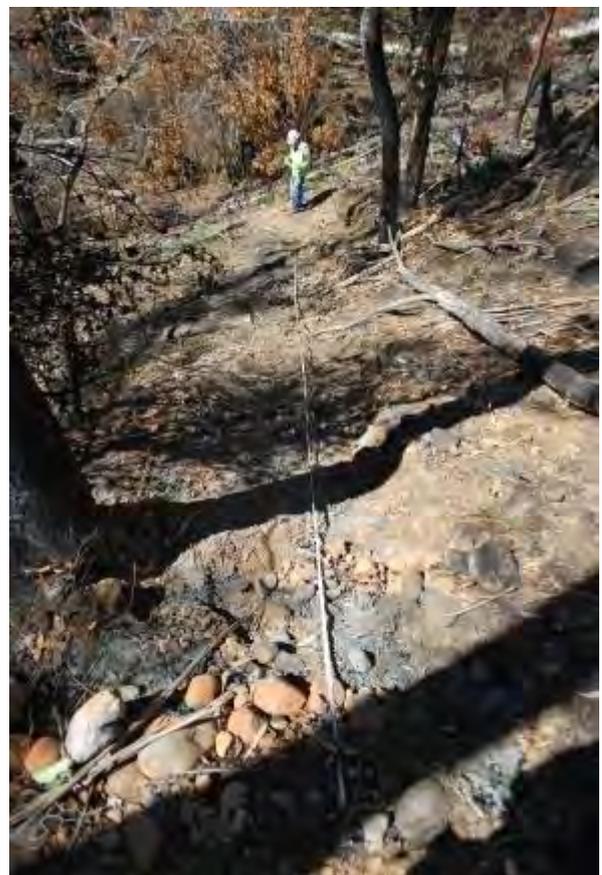
Upstream of the toilet block (to the right) the bridges and staircase have all been burnt. There are three platforms on the river bank in this area (upstream of the washing machine). The one most upstream is undamaged whilst the middle one is burnt at both ends and also crushed by a fallen tree. The lower platform was not assessed.

Burnt out bridge at left and staircase at right

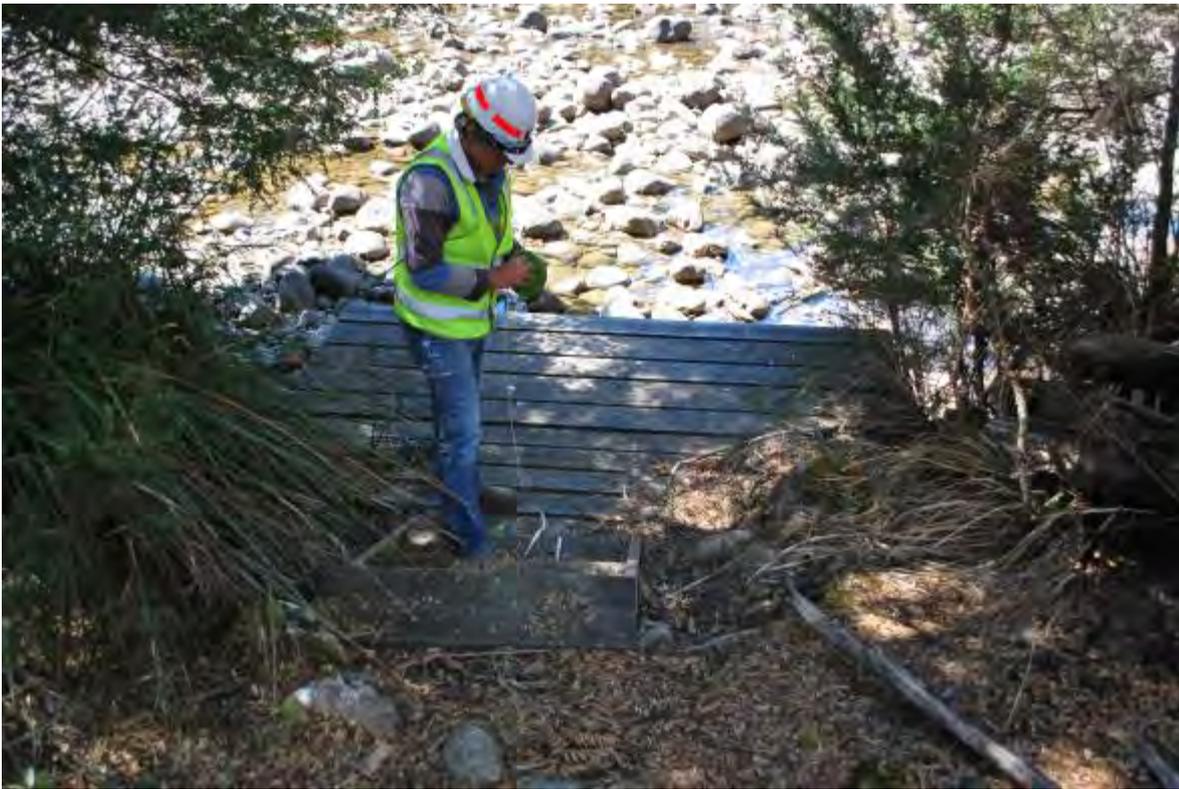
Platform above the Washing Machine

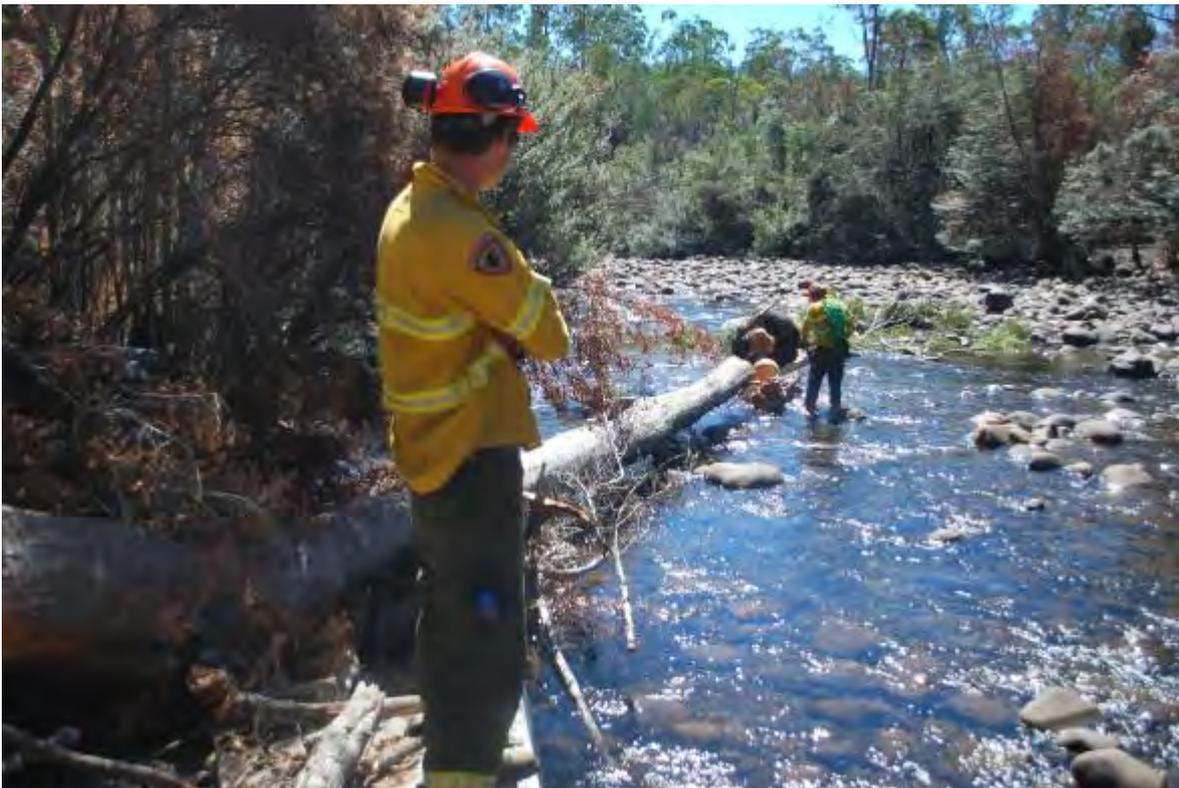
Around 6 trees had fallen into and across the river between the Platform above the Washing Machine and Gemini Rocks. The Tasmanian and New South Wales Parks and Wildlife Service fire fighters were busy cutting these up so that they will hopefully float free and not remain a hazard to paddlers. A couple of the wires from slalom gates had felled into the river and were pulled to the side.

Tasmanian Parks and Wildlife Service fire Crew cutting up one of the trees in the river

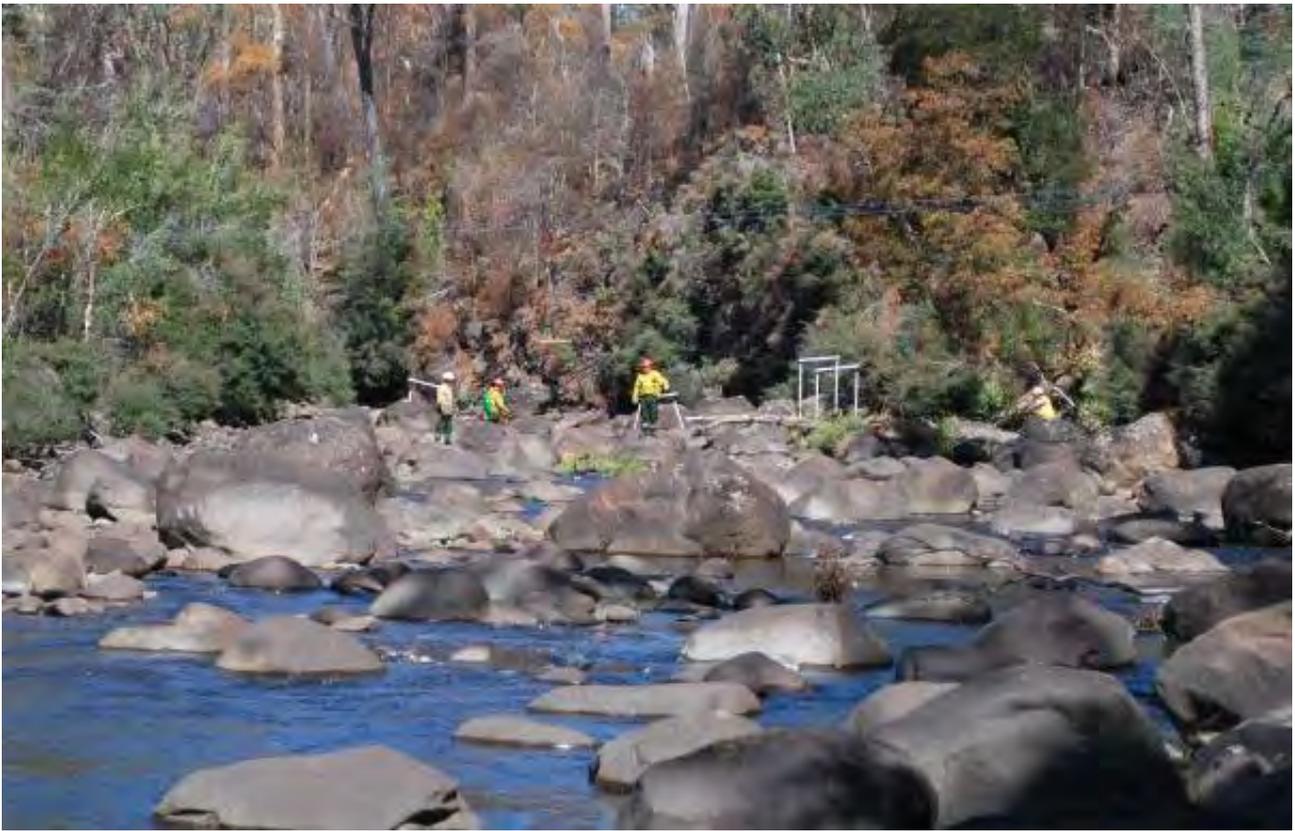
Tasmanian and New South Wales Parks and Wildlife Service Crews cutting up trees in the river below the Washing Machine.

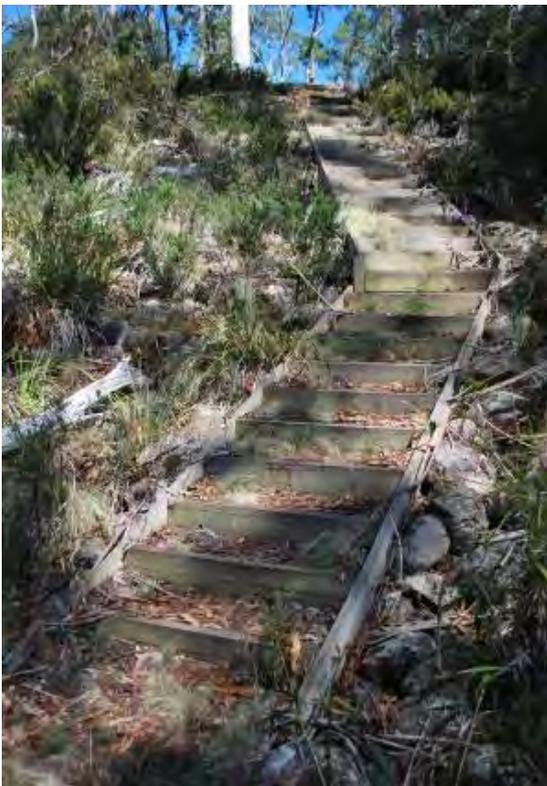
Downstream of the picnic area the damage was not as great. The main staircase leading down to the river just above Gemini Rocks and the Staircase at the lower car park are both intact as are all of the platforms on the river bank.

Staircase up to lower car park

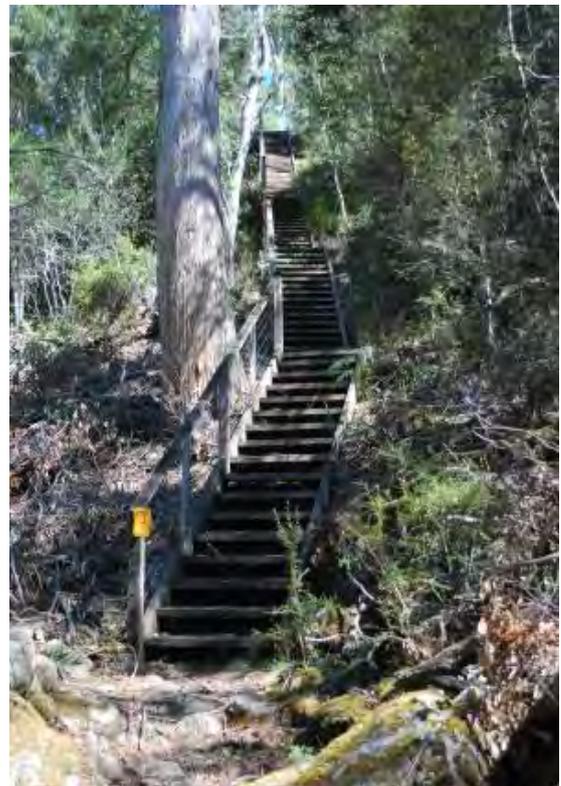
Staircase up to main picnic area

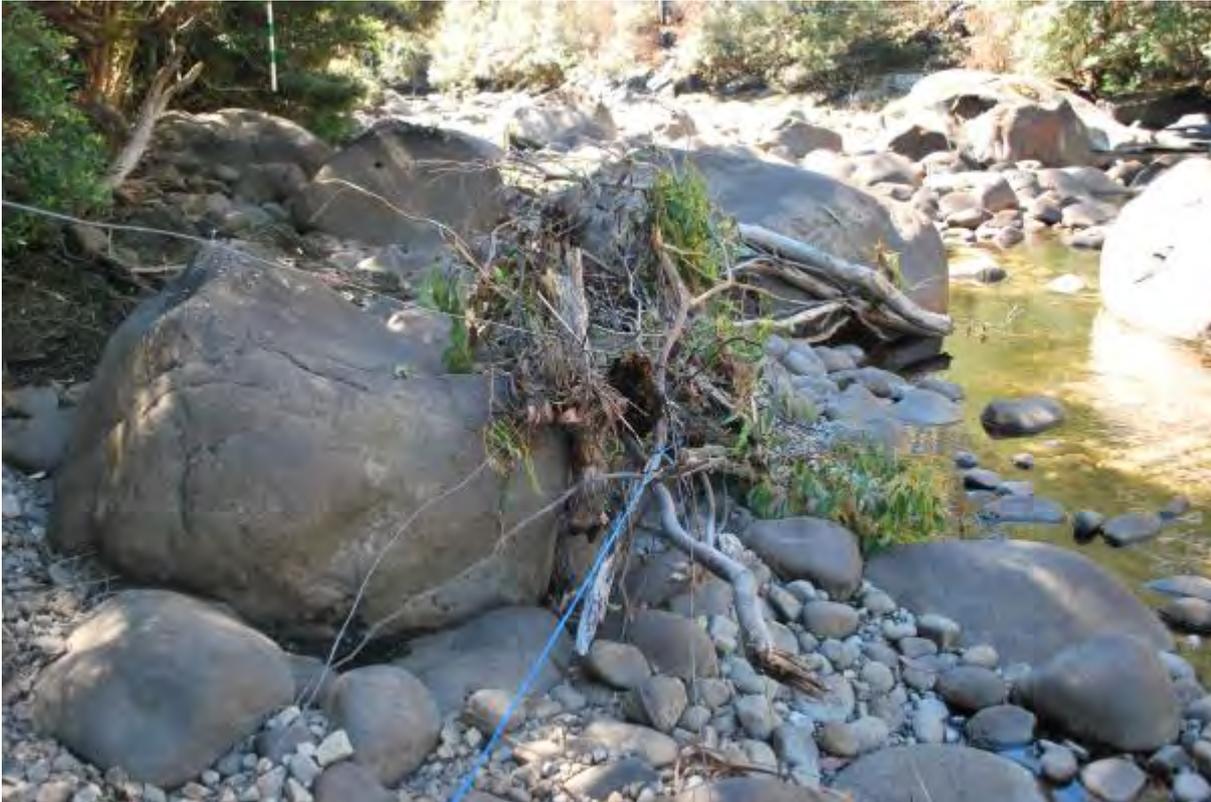
Unfortunately in this area around half of the slalom gate wires and return wires have come down. Quite a few of the trees that wires were attached to on the right bank have burnt out with the wires coming down across the river as a result. Some of the return strings have simply burnt at the river right end with the remainder falling into the river. Most of the wires and ropes that have come down turned into a tangled mess when the water was turned back on. Most of these have now been removed and put up on the river left bank out of the way.

There are about four gate wires and three sets of return wires in this tangle.

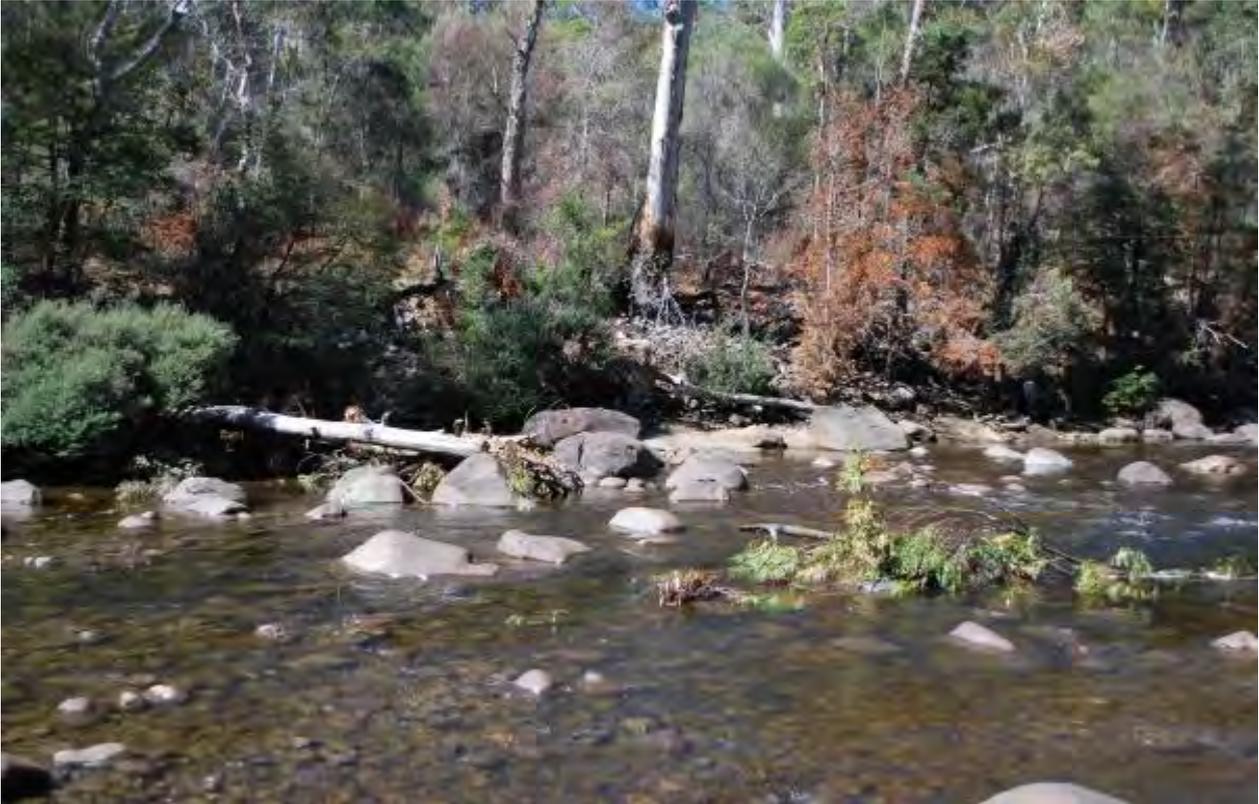
There are two logs in the river in this section. One is about midway down the course in an eddy on the right and the other is at the bottom of the course lying on the rocks just above the last main rock in the middle of the river (often has an up left gate below it). Both of these will need to be removed but the Parks crews did not have time before the water was turned back on. They will reschedule this soon.

Slalom Course logs in river

- **it has been confirmed that the known trees that are still across the river in dangerous locations have been removed,**
- **the entire slalom course has been checked for wires and ropes in the river and these have been removed, and**
- **that a party has checked the remainder of the river from the bridge below Rowallan Dam down to Lake Parangana and confirmed that it is safe for normal use.**

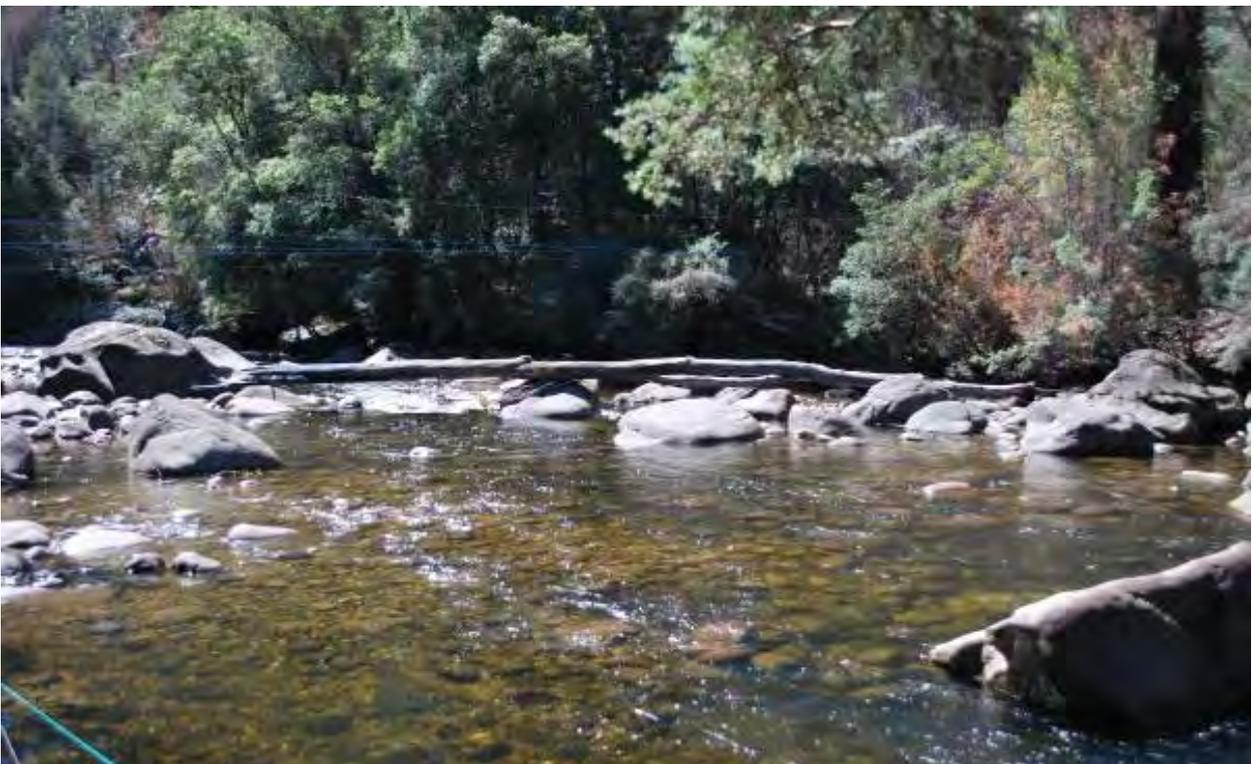
Slalom Course logs in river
